## Restoration of the Jocko River Near Arlee

*Les Evarts, Project Leader: Confederated Salish & Kootenai Tribes*

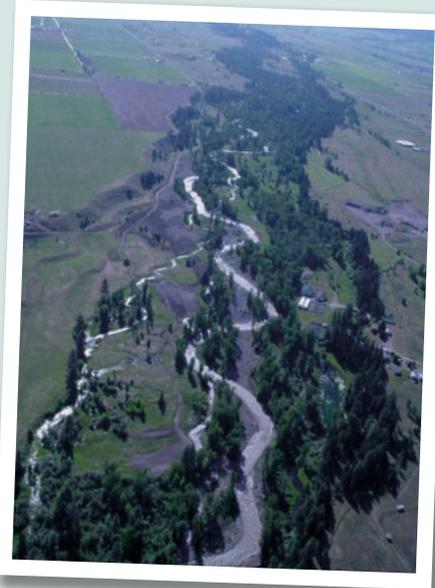
**After Restoration:** Efforts re-established hydrologic connection with the Jocko River floodplain and re-activated disconnected meanders. The restored channel plan form and connected side channels emulate the pre-disturbance condition of the Jocko River, improving habitat for bull trout and other aquatic species.

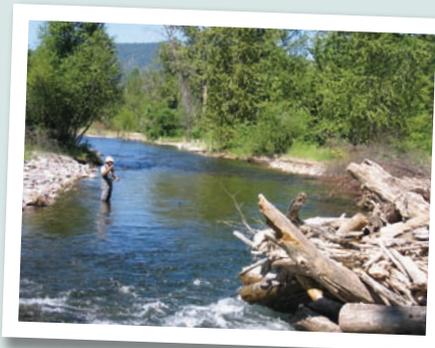
**Jocko Angler:** The use of large wood habitat structures and a variety of bioengineering techniques have increased the frequency and depth of pool habitats on the Jocko River. Important habitat components of Montana rivers, large wood, pools, and riparian vegetation function to diversify riverine ecosystems while providing recreational opportunities

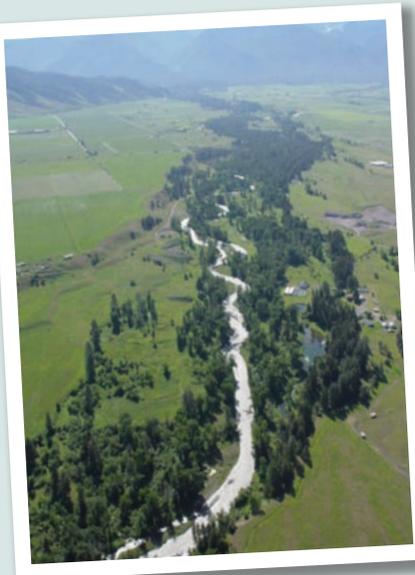
**Before restoration:** Historical impacts to the Jocko River channel and floodplain resulted in impaired aquatic habitat conditions and loss of riparian and wetland functions.
