Hallowat Creek Fish Habitat Restoration

*Troy Brandt, Fisheries Biologist
River Design Group, Inc.*

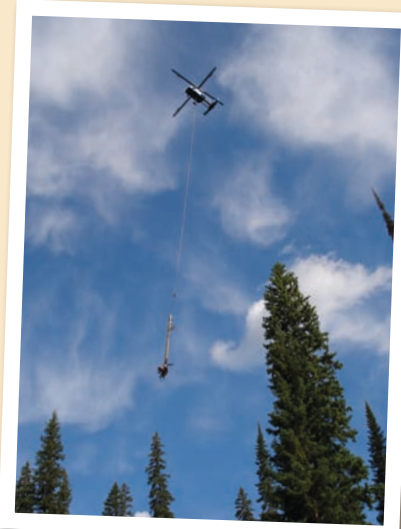
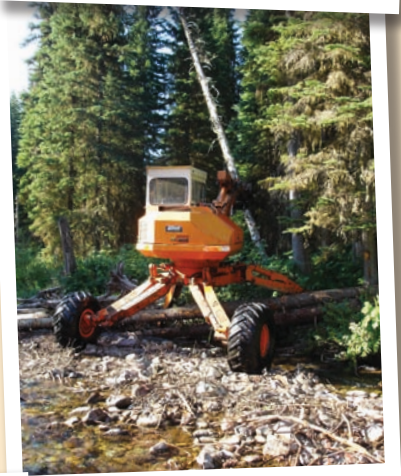
A helicopter and spider excavator were used to build large wood structures designed to provide bull trout habitat, trap spawning gravels, and increase channel complexity

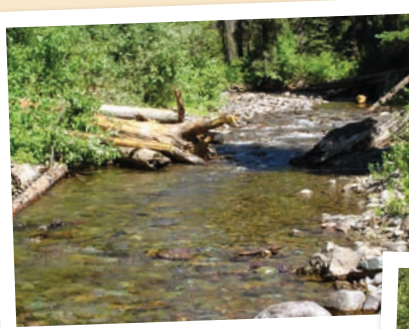
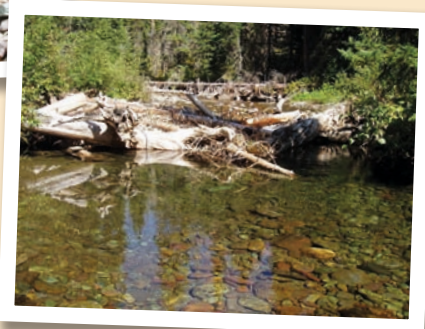
An example large wood habitat structure following construction (above) and three years after construction (right). This structure accumulated more wood and generated channel scour, providing cover for juvenile bull trout and other species.

suggest the most stable structures were ones that were comprised of an existing natural large wood jam that was augmented with additional wood. Pool habitat increased in the three monitoring reaches, with expansion of pool habitat related to both large wood structure locations as well as channel hydraulics unrelated to installed large wood. On-going bull trout spawning monitoring completed
